Re: Sound Transit East Link Non-Destructive Testing Demonstration / Evaluation
Mayes Testing Engineers Project Number S08040

As requested, on June 2 & 3, 2008 Mayes Testing Engineers performed a limited reinforcing steel survey of precast, pre-stressed concrete elements in order to demonstrate three commonly used technologies used to non-destructively locate embedded reinforcement.

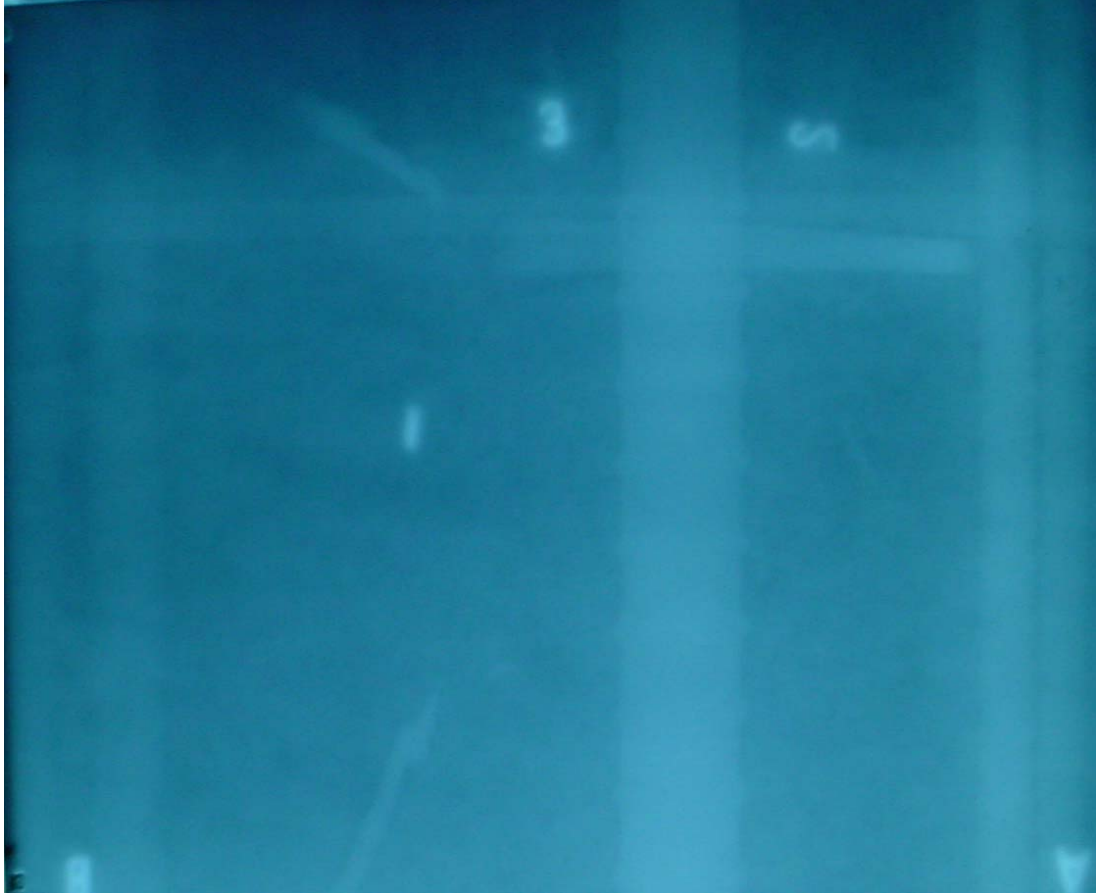
WSDOT Geneva Maintenance Facility
Test Element X-ray #2

At the location of the second x-ray image, pachometer had identified an area where the vertical reinforcing steel appeared to be discontinuous. The vertical bar located 48-inches from the left edge of the element could not be detected via pachometer in an area from approximately 24-inches to 36-inches above the bottom of the wall. Further scanning with GPR also provided similar indications, while the WSDOT record drawing indicates that this bar should be continuous over the full height of the wall. The x-ray image performed corroborates the pachometer and GPR results, and does not show any indication of the vertical bar in this area.

Resolved discrepancy between the WSDOT record drawings and the GPR & pachometer regarding location of vertical reinforcing steel.

Lack of vertical reinforcement at location 1 on x-ray indicates vertical reinforcement is not continuous at this location

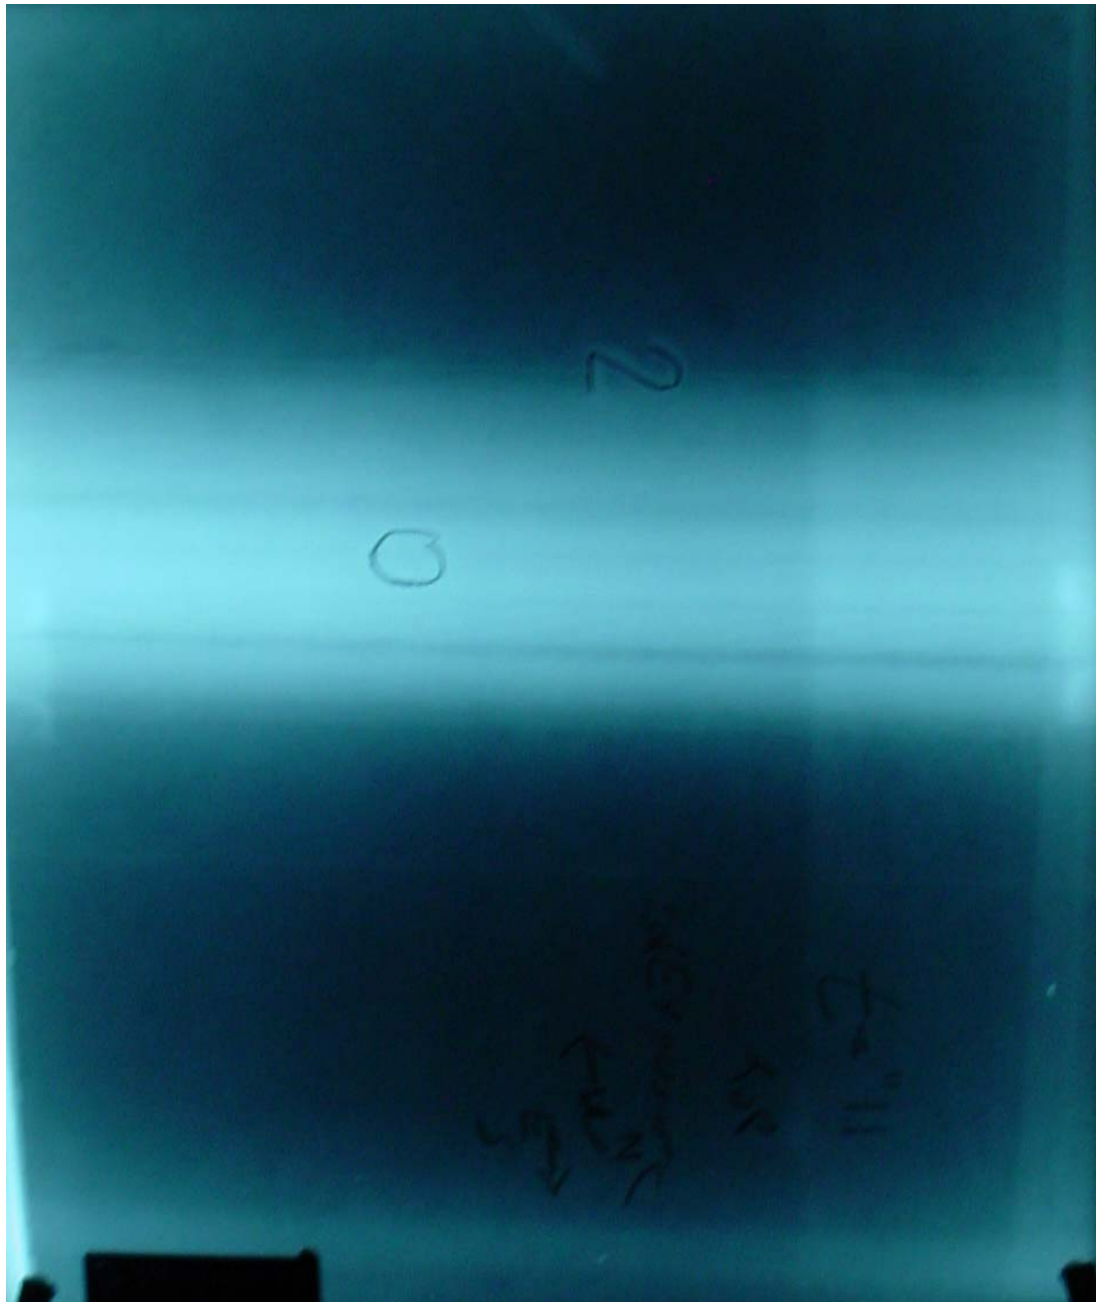
WSDOT I-90 Floating Bridge
Pontoon A, 11-inch Top Deck Section

X-ray images performed at both of these locations verified the detection of top mat reinforcing steel by both pachometer and GPR and the grouted post-tension duct by GPR.

Verifies GPR detection of transverse grouted post-tension duct (top horizontal in picture) and pachometer detection of mild steel reinforcement (left, right and bottom edges in picture)
